**SB Number:** SB27A

**Topic:** Temperature Sensor Replacement on CEN Temperature-Voltage Sense Harnesses With or Without Other External Connections such as J1939 Connectors

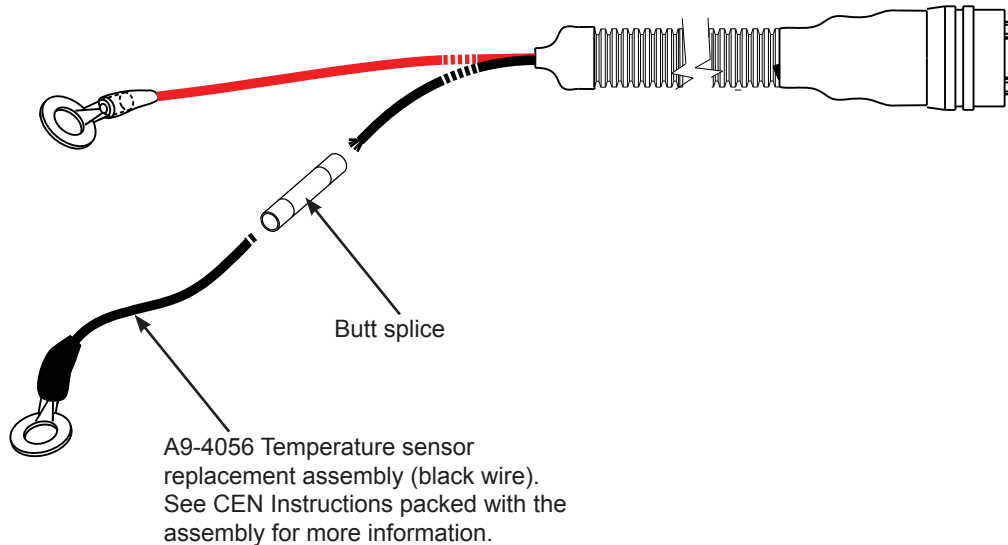
When troubleshooting the CEN temperature-voltage sense harnesses, the harness may prove defective either at the temperature sensor or in the entire harness.

If the temperature sensor in the B- terminal black wire is proven defective, the sensor and terminal assembly can be replaced with the A9-4056 temperature sensor terminal assembly. Contact your CEN Factory-Authorized Service Dealer or CEN Aftermarket Group for further information.

The entire temperature-voltage sense harness can also be replaced as an alternative to replacing just the sensor assembly. Contact your CEN Factory-Authorized Service Dealer or CEN Aftermarket Group for further information.
